PERFORMANCE RESULTS EXAMPLE

Oil Refinery (Pernis - Netherlands)

→ Leaking Air Cooler

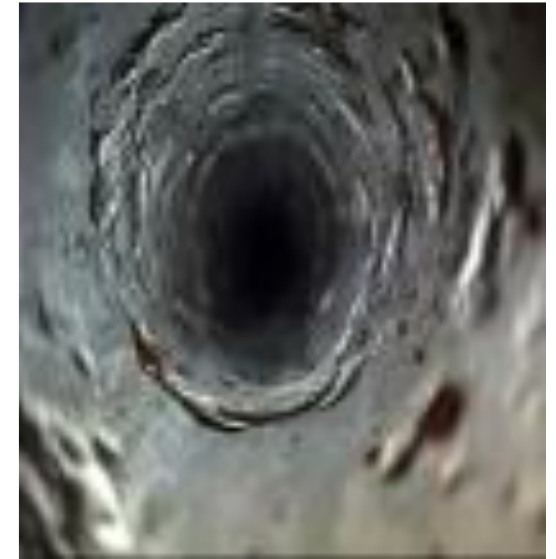
Tube Size	0.78" ID (19.88 mm)
Material	A179
# of Tubes	261
Inspection Time	1.5 hours total (including set-up) during weekend
Shape	Straight tubes
Defects Found	<ul style="list-style-type: none"> •2 holes (0.6 mm and 0.2 mm) •Holes within 10 cm of beginning

- Sound Tube Testing performed accurate inspection very quickly
- Holes found by Sound Tube Testing were missed using conventional inspection techniques
- Both tubes were plugged and problem was solved
