Inspection Results

Combined Cycle Power Plant (Turkey)

→ Condensers

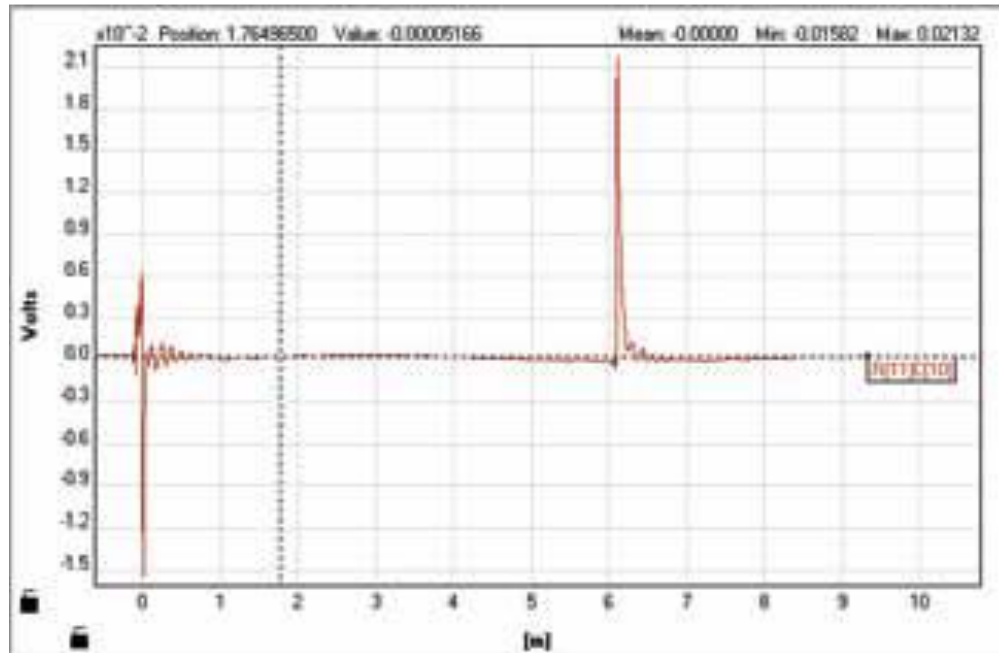
Unit 1 DOWN-NORTH Section 1 R11 C10

→ Blockage – Before Cleaning

- Air pressure tests were performed on all tubes with total and severe blockages. All tubes were completely cleaned.
- Tube with severe wall loss was plugged.
- Customer informed owners about the status of the condensers and advised them to inspect again with Sound Tube Testing during the next shutdown. This will allow monitoring of the tubes for potential leakage due to bad rolling indications.

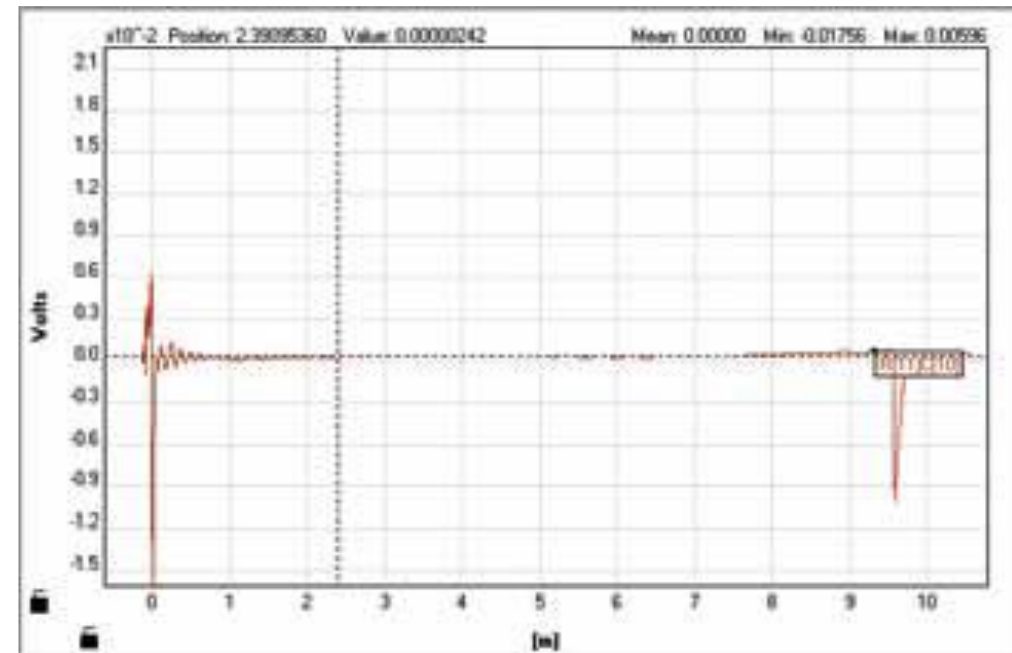
→ After Cleaning

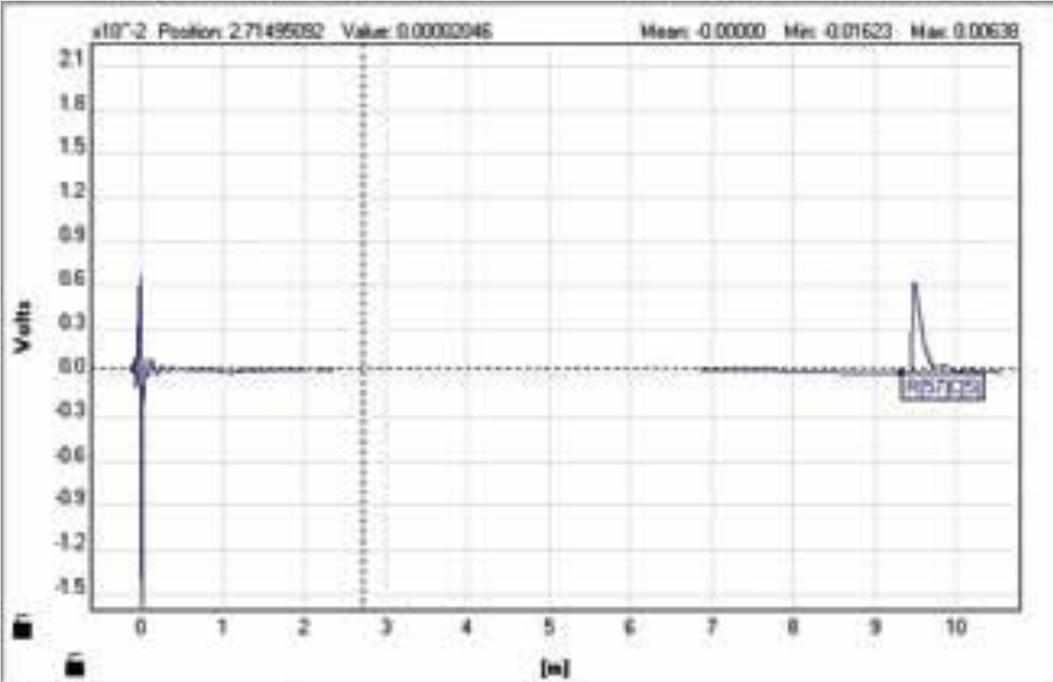
Unit 1 DOWN-NORTH Section 4 R57 C5

→ Blockage – Before Cleaning

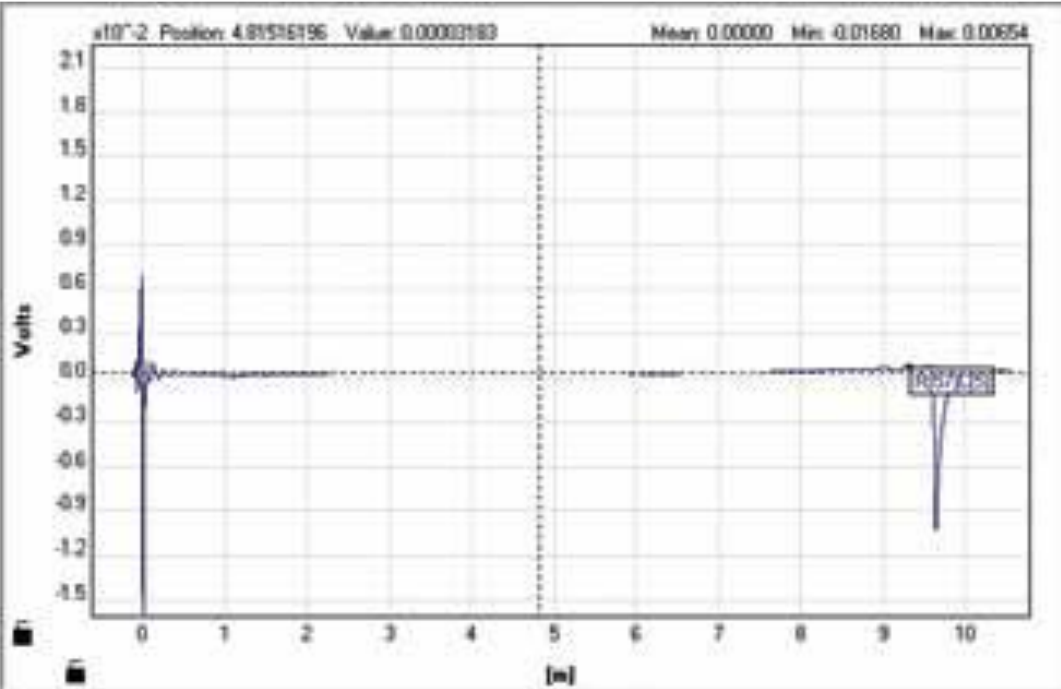
→ After Cleaning
