# PERFORMANCE RESULTS EXAMPLE

## Food & Beverage Industry (Netherlands)

→ Condenser in milk factory

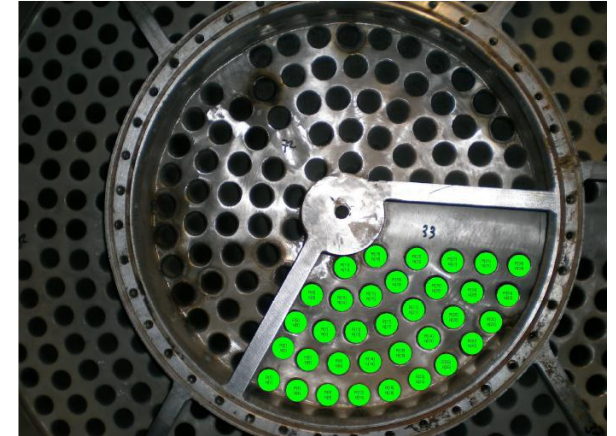
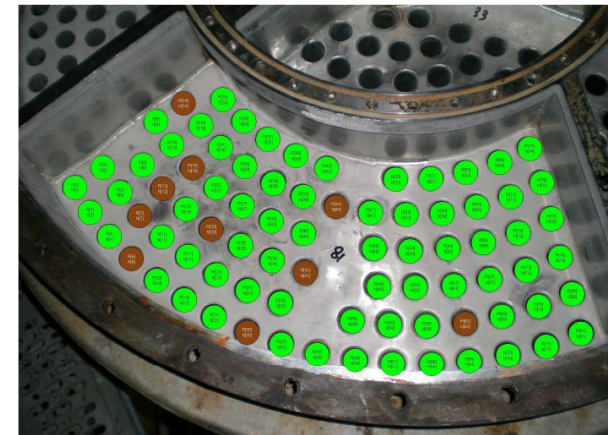
Tube Size	40 mm ID (1,575")
Tube length	5 m
# of Tubes	484
Inspection Time	½ shift including setup
Defects Found	16 tubes with multiple holes

→ Tubes with holes were plugged and condenser very fast back in operation
