Report number

SZMF-ED-UB-2012-0125

Applicability of Acoustic Pulse Reflectometry to injector and heat exchanger tubes with typical manufacturing flaws

October 10, 2012

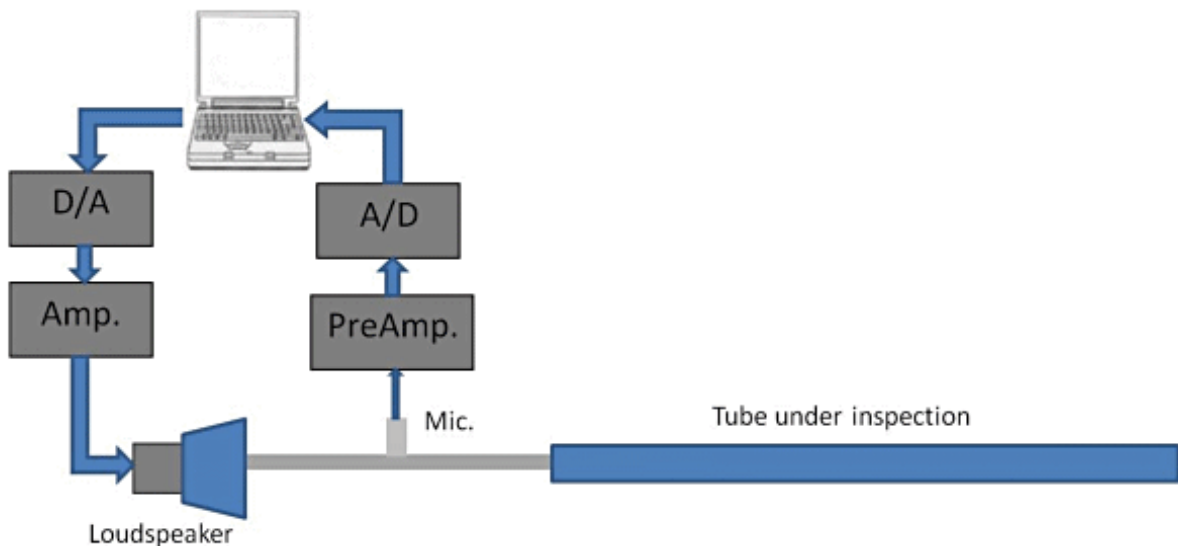
In the sketch above, the design of an APR system is depicted. A computer generates a digital pulse or a well-defined sequence of pulses which are digital to analogue converted, amplified, and sent to a loudspeaker. The loudspeaker then generates a corresponding acoustic wave which travels through an interface tube (adapter) to the tube under inspection. Any defects or blockages in the tube that change its cross-section cause reflections that travel back up the tube and pass the microphone which is located in the wall of the interface tube. One reflection is always caused by the end of the tube.

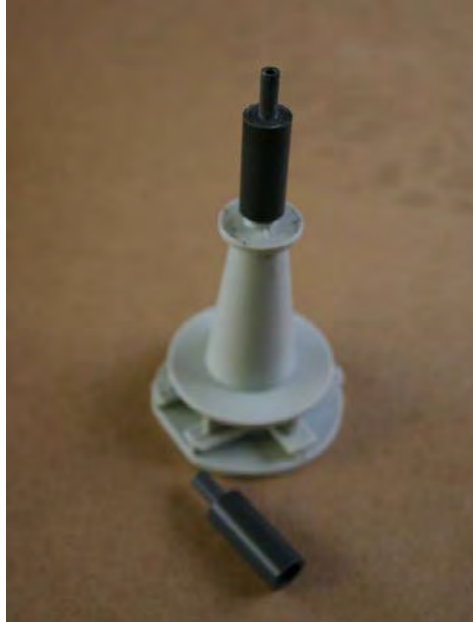
Figure 2: Turned adapter for tubes with inner diameter smaller than 8 mm.

Conventionally, the AcousticEye system is used for tubes with an inner diameter of 8 to 102 mm. For those dimensions different types of adapters exist to couple the acoustic impulse into the tube. This led to the need of an additional adapter for the tubes with an inner diameter of less than 8 mm. This adapter has been turned in our workshop and is shown in Figure 2.

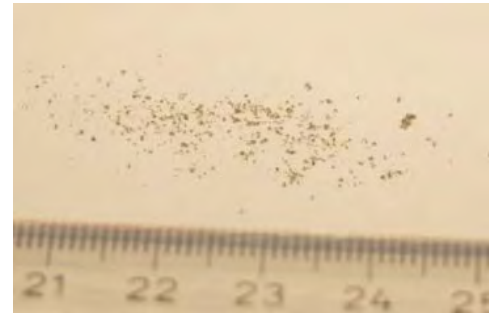
In this group two indications occurred. The first irregularity was a sub-threshold blockage in a good labelled tube which can be seen in Figure 5. After cutting this tube, some loose, small chips could be found in there. This is an example for a flaw which cannot be detected by UT measurements, but by the APR system.

Figure 5: Result of a measurement showing a sub-threshold blockage in a good labelled tube.

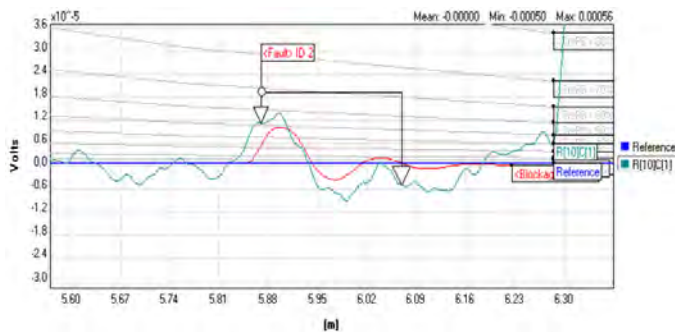
The second flaw detected by APR was a small blockage at the end of the tube at about 5.85 m. After cutting the tube at the particular position a chip and some dirt particles appeared. The results are depicted in Figure 6.

Figure 6: Indication of a blockage which turned out to be a chip at the end of the tube.

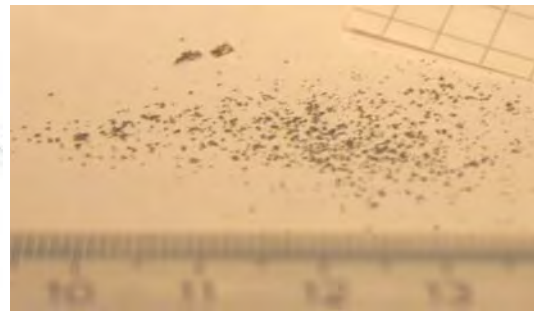
In group 3 (inner diameter of 5 mm) an extended blockage was indicated by the APR system. By analyzing the inside of the tube it became clear that this indication is due to small particles inside the tube which were spread over a wider area of about 1 m. The result is shown in Figure 7.

Figure 7: Indication of some particles spread over an elongated area inside the tube.

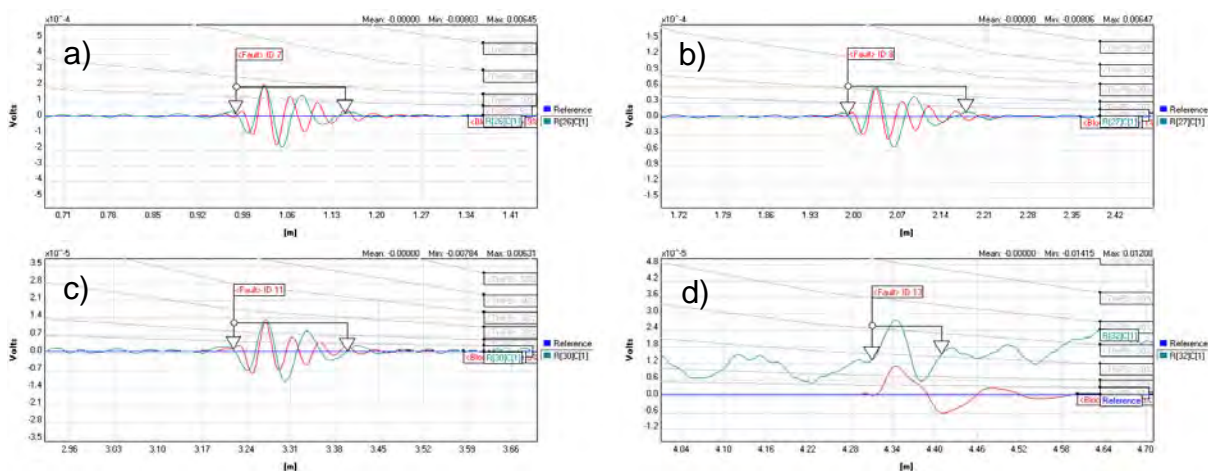
To simulate simple blockages inside a tube, a piece of copper wire with a diameter of 1.2 mm and a length of about 31 mm has been inserted into a tube with inner diameter of 5 mm at positions 1 m, 2 m, 3.2 m, and 4.3 m. Results of these measurements are depicted in Figure 8.

Figure 8: Indication of a copper wire (1.2 mm) inside a tube with an inner diameter of 5 mm. Position of the artificial flaw from the tube end: a) 1 m, b) 2 m, c) 3.2 m, d) 4.3 m

One can observe that the thin wire with a filling factor of about 6 % is clearly detectable at the distances 3.2 m or closer to the tube end from which the measurements have been performed. The blockage has also been detected at the 4.3 m position, but with a lower signal to noise ratio. Obviously, the energy of the acoustic pulse is smaller than in case of larger inner tube diameters. Hence, the maximum measurable length of these tubes is smaller. One reason for this is that it is more difficult to induce the same amount of acoustic energy into the small opening of small inner diameters. However, one has to keep in mind that the adapter we used for the trials was improvised. With a more optimised adapter, it would be possible to induce energy more efficient into the tube.

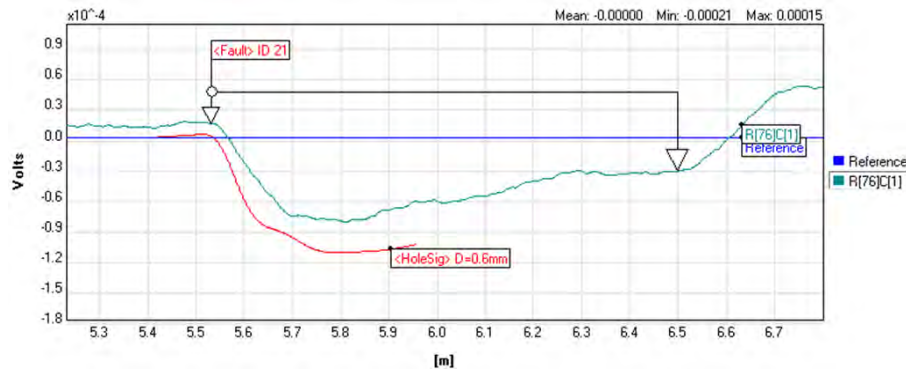
Even if holes are not typical defects for the manufactures, a few tests with drilled holes of 0.8 mm diameter have been performed. The positions of the holes were at several distances up to 5.5 m to the tube end. Each of those holes could be detected very clearly. Figure 9 shows the result of the farthest (5.5 m) hole.

Figure 9: APR signal of a tube with a drilled hole at 5.5 m.

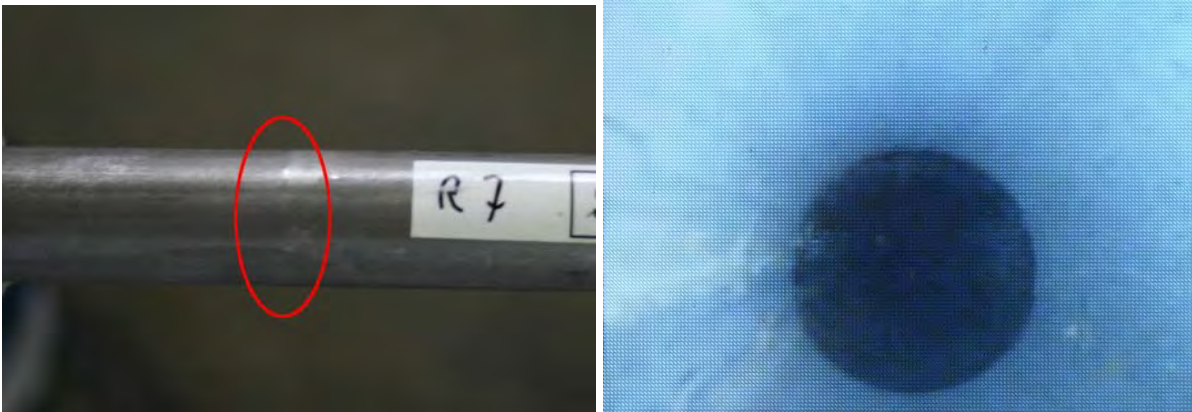
Flaws that may occur by production of SMP tubes are typically burned-in oil and dirt, chips, grooves, and marks where the mandrel, a part of the inner die in the production process, broke. The latter one consists of an abrupt change in the inner diameter (an example is shown in Figure 10). The chips can occur loose or they can be fixed and reach into the interior of the tube. Examples of such chips are shown in the subsequent sections (e.g. Figure 13).

Figure 10: Marks of a mandrel break: The inner diameter changes abruptly. Left: View from outside, right: The inside at this change, seen by an endoscope.

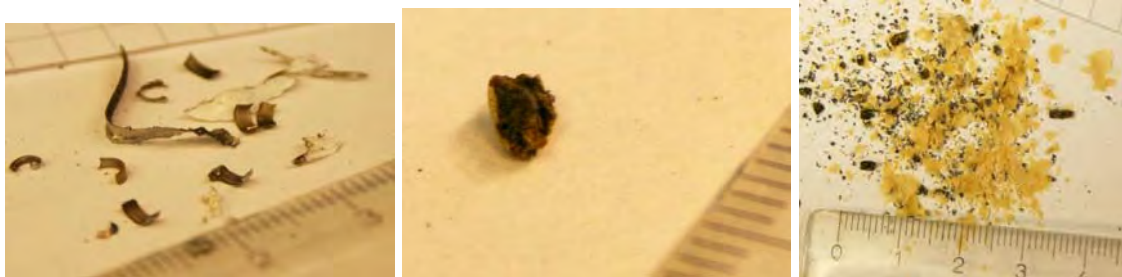
Here, three tubes contained burned-in oil and chips and two contained marks of mandrel breaks. As before, the burned-in flaws were not classified as defects, but led to a higher noise level. The two mandrel break marks could clearly be seen. Furthermore, we again found some more unspecified flaws: One tube contained one large and several smaller chips, in another one we found something like a small stone. Finally, as in group 2, one tube contained paper-like dirt, mixed with small chips (see Figure 16). The APR signals of the chips and the stone are depicted in Figure 17; the signal of the dirt is similar to that from the dirt in group 2. One can observe that the large chip was positioned at about 0.38 m, whereas the smaller ones are distributed a few centimetres around it.

Figure 16: Non-specified flaws in group 3: Several chips, something like a small stone, paper-like dirt mixed with small chips.

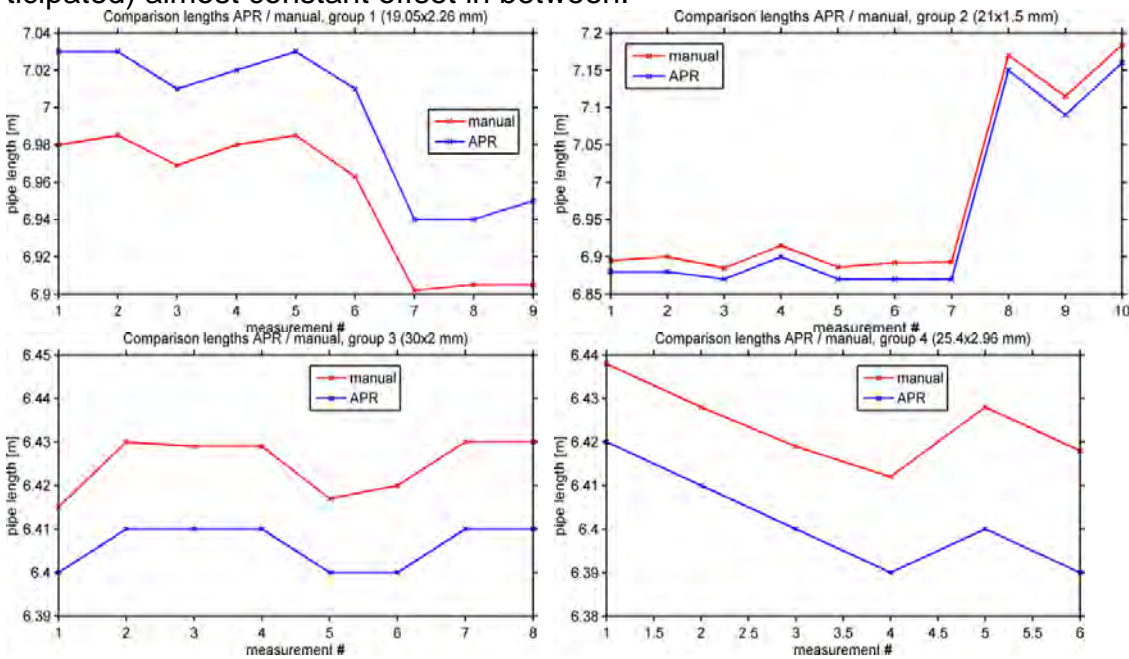
In Figure 23, the results of the APR lengths are compared to the manual measurements. For each group, the two curves have a very similar progress, but with an (anticipated) almost constant offset in between.

Figure 23: Comparison between the manual length measurement and the lengths extracted from the APR-measurements.
