Validation of the APR-technique

WP5: summarizing evaluation

FINAL REPORT

Date : 12th July 2013
Author : ir. J.H.A.M. Heerings
Client : Stichting KINT Onderzoeksprojecten

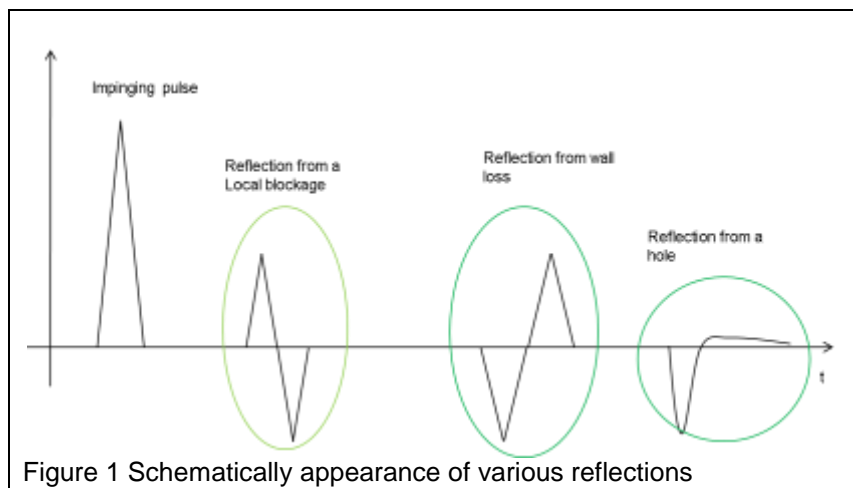
Figure 1 Schematically appearance of various reflections

The physics of the APR-technique are based on emitting a wideband acoustic pulse in the air enclosed within the tube. The frequency range is about in the range of 10 Hz - 10 kHz. If a discontinuity is encountered in the form of a change of cross section, reflected waves are created, which propagate back up the tube. Upon recording the acoustic reflections by a microphone, they are analyzed automatically. Schematically, the reflections will appear as shown in Figure 1.

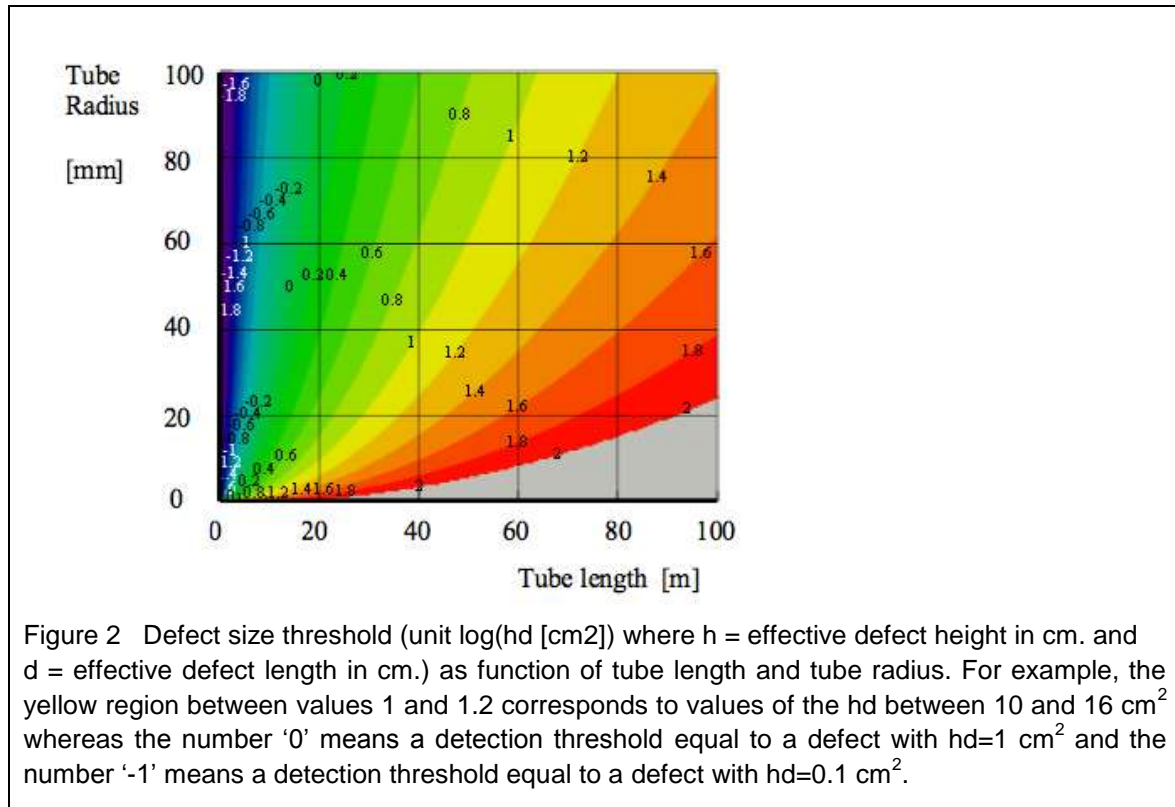
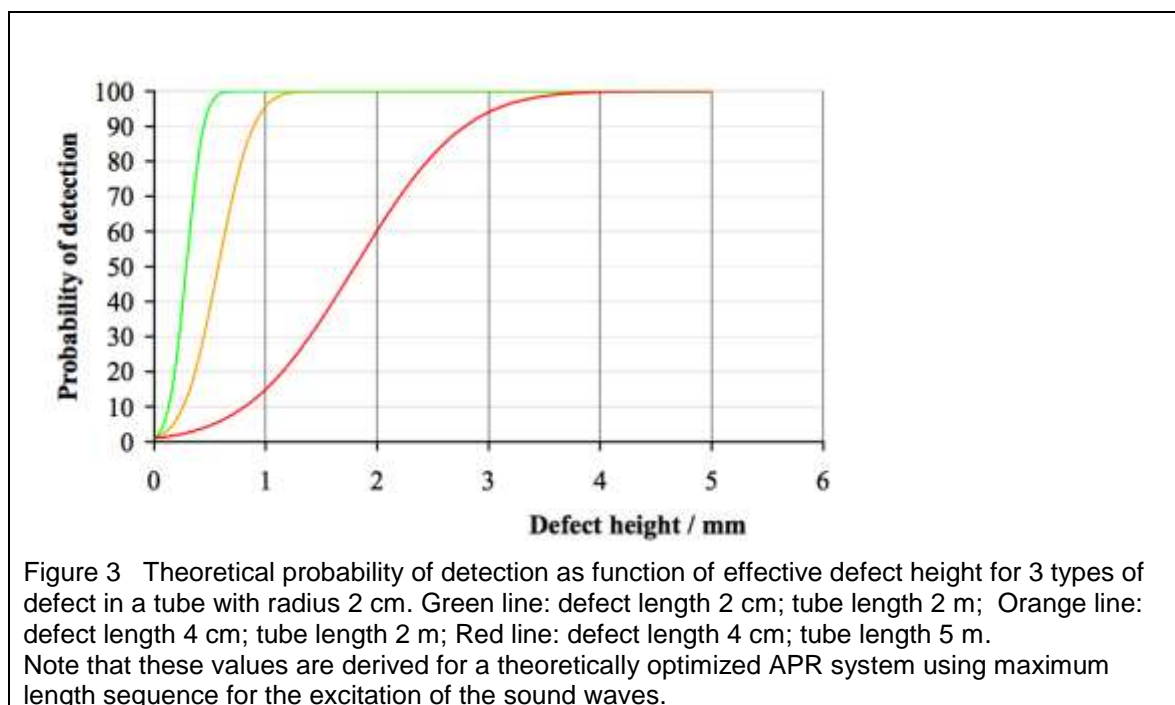
Based on these considerations, a theoretical model was initially developed, to predict probability of detection depending on the tube radius and length and defect type and size. This model gives a defect size threshold as shown in Figures 2 and 3. It should be noted that different type of defects can give similar responses. These figures apply to the situation that the defect is present along the whole circumference of the tube. If only a fraction of the circumference contains the defect, the effective 'h' will be diminished by the same fraction.

The theoretically derived probability of detection can only be used to demonstrate the dependence of the probability of detection as function of defect sizes and tube parameters. The actual probability of detection depends on instrumental settings and noise contribution. If for a certain defect type and size the actual probability of detection is measured, then this dependence can be used to predict the probability of detection for other defect sizes and geometries.

For this theoretically derived probability of detection the conservative condition was assumed that the signal-to-noise ratio obtainable for a maximum length sequence is limited to the number of pulses in the sequence and that the spatial resolution over the complete length of the tube should be constant.

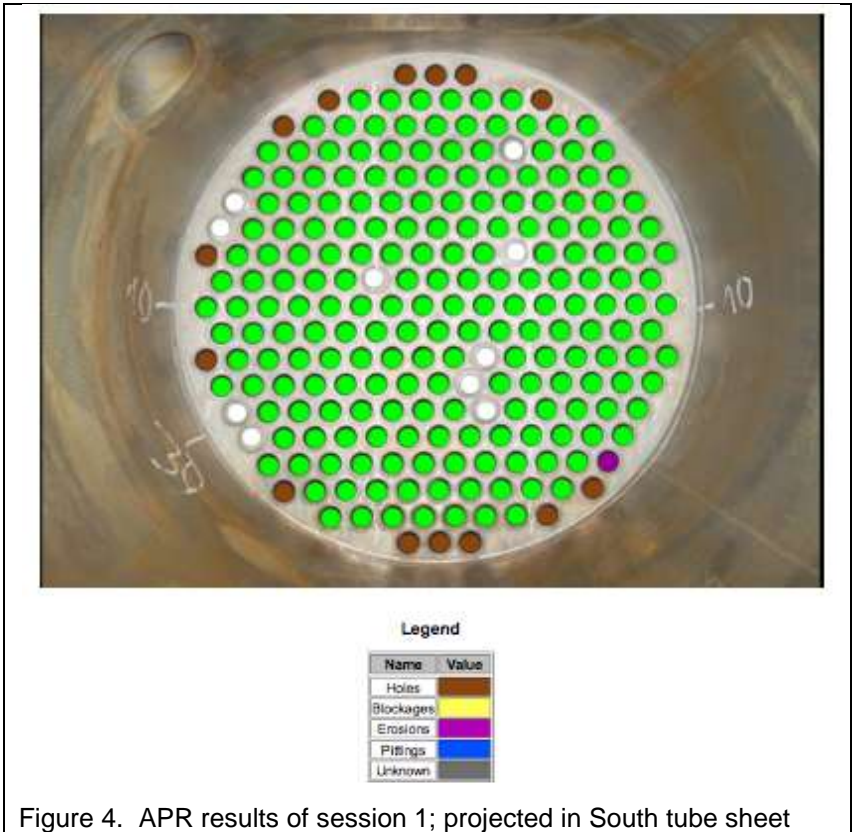
Figure 4. APR results of session 1; projected in South tube sheet

An interesting result of the APR inspection is the detection of holes as shown in Figure 4, see the brown coloured tubes. In the ET inspection wall reduction in the range of 80%-100% was detected, but not in the specific tubes which contain holes according the APR inspection. This deviation can be explained by the fact that ET inspection is capable of detecting smooth wall reductions in contrast to APR whereas APR is capable of detecting holes with very small diameter in contrast to ET. In order to verify the presence of the holes detected by APR, examinations have been conducted including both PT (dye penetrant testing) and visual examination (both outside with naked eye and inside with endoscopy). However, the presence of holes could not be confirmed. The explanation for this is most likely the fact that the removed tubes were cut behind the inner tube sheets and therefore

missed the most severely attacked section in between the inner and outer tube sheet (at the North side). In conclusion, it was not possible to verify the detected holes due to improper sampling in the retubing workshop.

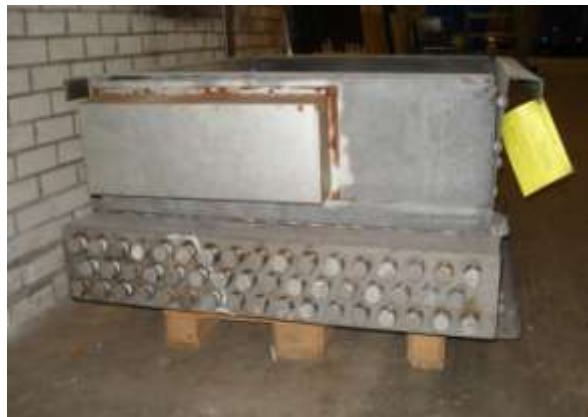
The size of the tubes is 25.4 x 2.77 mm. Length of tubes is 130 cm. The material of construction is carbon steel. The tubes are finned tubes. Figure 7 presents a view of the bundle.

Figure 7a View from outside of bundle
The 19 tubes are positioned on the left hand part

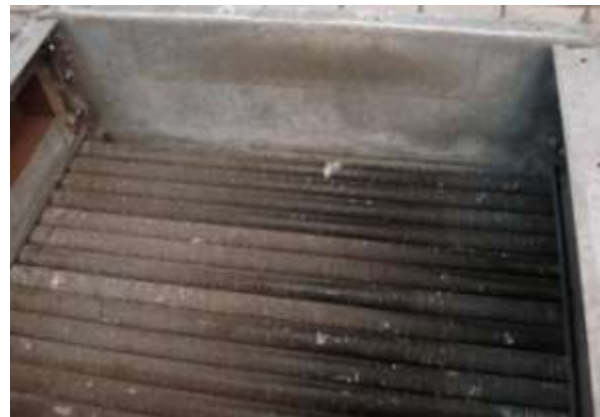
Figure 7b View on top row of finned tubes

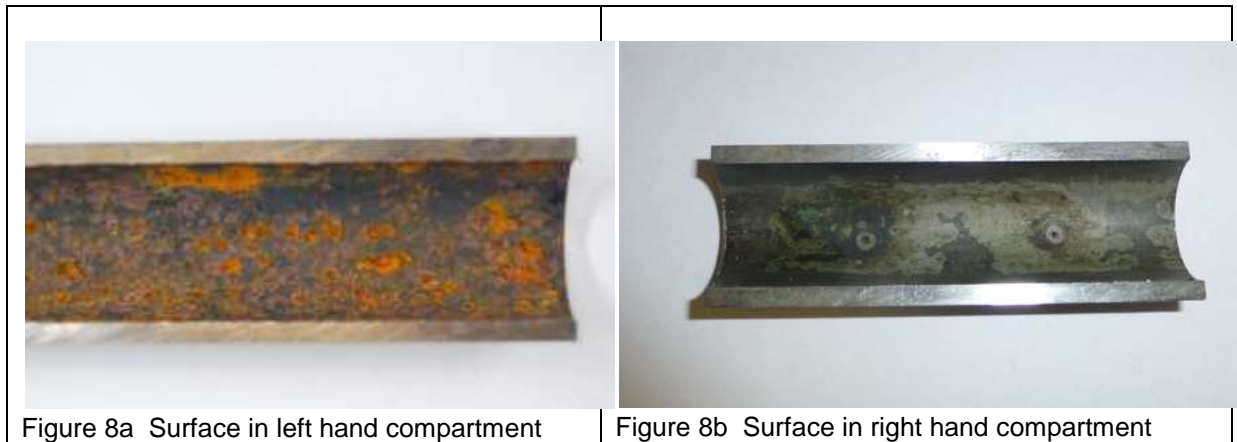
The internal surface of the tubes appeared to have a pitting morphology which is different for the left hand compartment and right hand compartment due to the difference of fluid and operating conditions. The pitting in the left hand compartment is more severe, as can be seen in Figure 8.

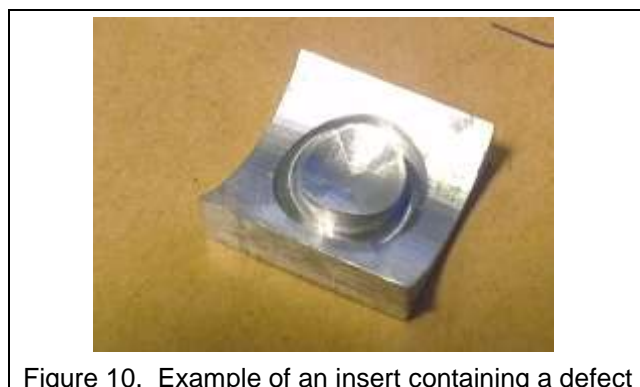
The wall reductions were manufactured by making use of machined inserts which were made from aluminium. The inserts were positioned and glued in a machined through wall slot in the tube, see Figure 10.

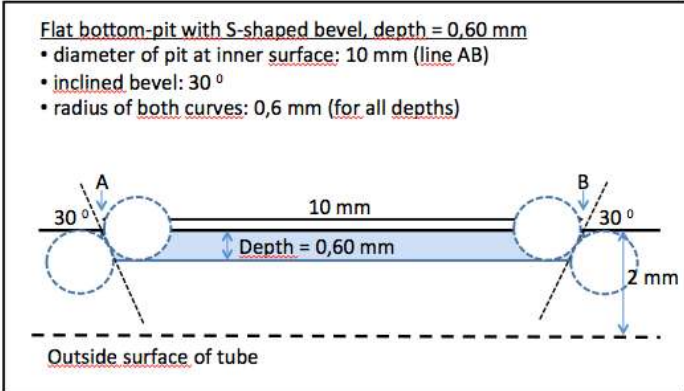
Definition of defect morphology	Resulting defect
<p>Flat bottom-pit with S-shaped bevel, depth = 0,60 mm</p> <ul style="list-style-type: none"> diameter of pit at inner surface: 10 mm (line AB) inclined bevel: 30° radius of both curves: 0,6 mm (for all depths)

<p>Outside surface of tube</p> <p>Type SS, definition of curvatures</p>

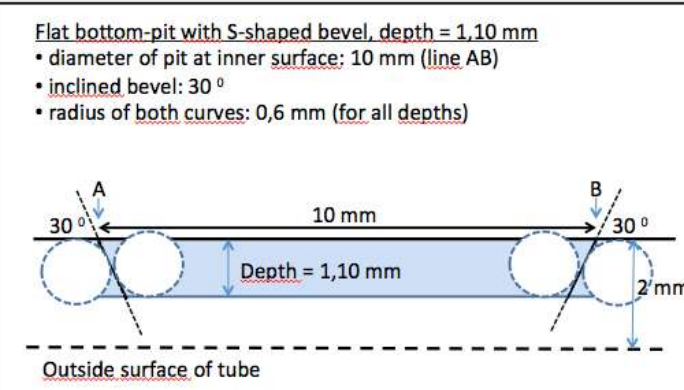
<p>SECTION A-A</p>
<p>Flat bottom-pit with S-shaped bevel, depth = 1,10 mm</p> <ul style="list-style-type: none"> diameter of pit at inner surface: 10 mm (line AB) inclined bevel: 30° radius of both curves: 0,6 mm (for all depths)

<p>Outside surface of tube</p> <p>Type SM, definition of curvatures</p>

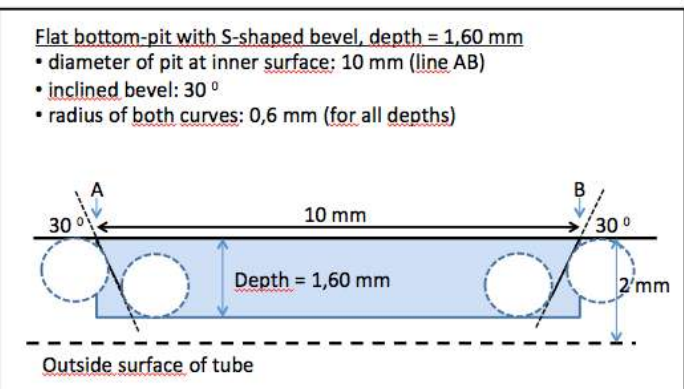
<p>SECTION A-A</p>
<p>Flat bottom-pit with S-shaped bevel, depth = 1,60 mm</p> <ul style="list-style-type: none"> diameter of pit at inner surface: 10 mm (line AB) inclined bevel: 30° radius of both curves: 0,6 mm (for all depths)

<p>Outside surface of tube</p> <p>Type SL, definition of curvatures</p>

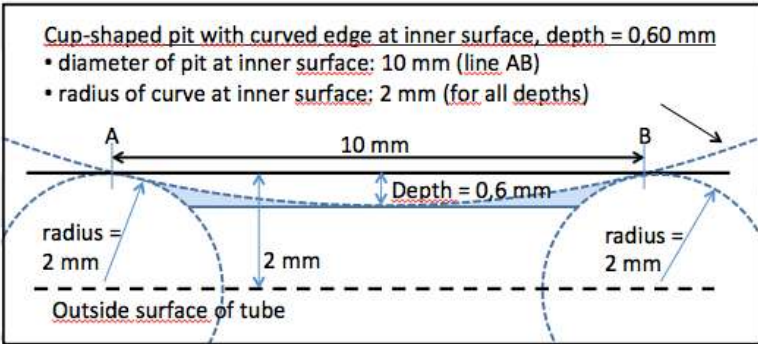
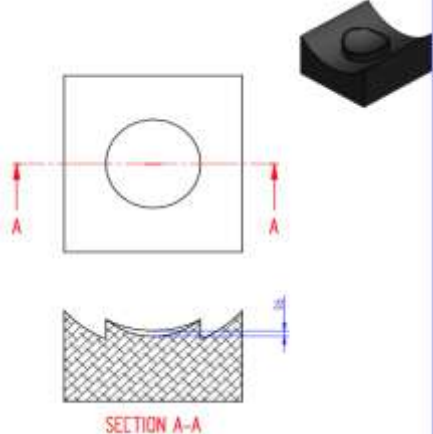
Definition of defect morphology	Resulting defect
<p>Cup-shaped pit with curved edge at inner surface, depth = 0,60 mm</p> <ul style="list-style-type: none"> diameter of pit at inner surface: 10 mm (line AB) radius of curve at inner surface: 2 mm (for all depths)

<p>Type CS, definition of curvatures</p>

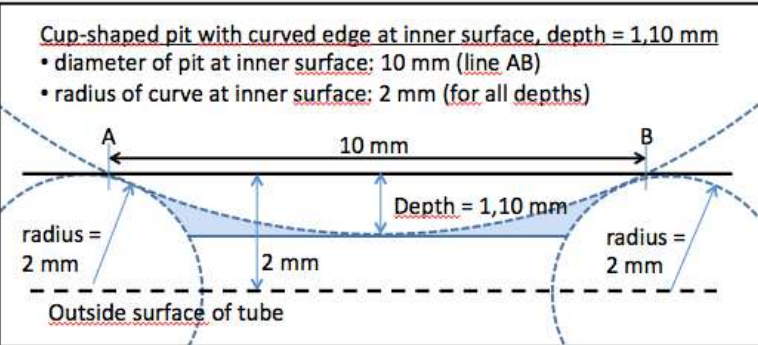
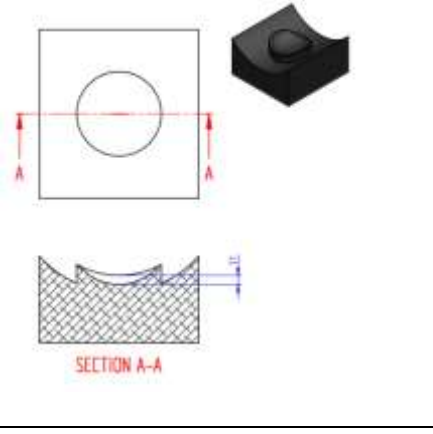
<p>SECTION A-A</p>
<p>Cup-shaped pit with curved edge at inner surface, depth = 1,10 mm</p> <ul style="list-style-type: none"> diameter of pit at inner surface: 10 mm (line AB) radius of curve at inner surface: 2 mm (for all depths)

<p>Type CM, definition of curvatures</p>

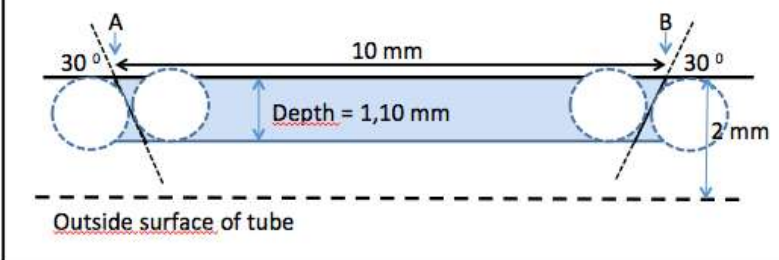
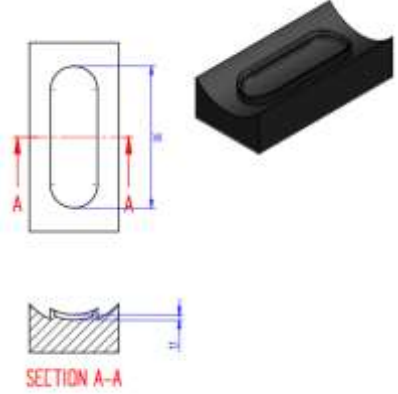
Definition of defect morphology	Resulting defect
<p>Flat bottom-pit with S-shaped bevel, depth = 1,10 mm</p> <ul style="list-style-type: none"> diameter of pit at inner surface: 10 mm (line AB) inclined bevel: 30° radius of both curves: 0,6 mm (for all depths)

<p>Outside surface of tube</p> <p>Type ASM, definition of curvatures</p>

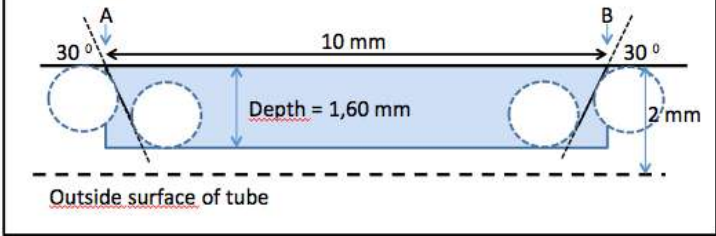
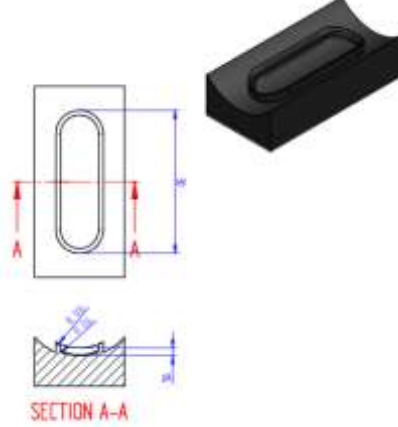
<p>SECTION A-A</p>
<p>Flat bottom-pit with S-shaped bevel, depth = 1,60 mm</p> <ul style="list-style-type: none"> diameter of pit at inner surface: 10 mm (line AB) inclined bevel: 30° radius of both curves: 0,6 mm (for all depths)

<p>Outside surface of tube</p> <p>Type ASL, definition of curvatures</p>

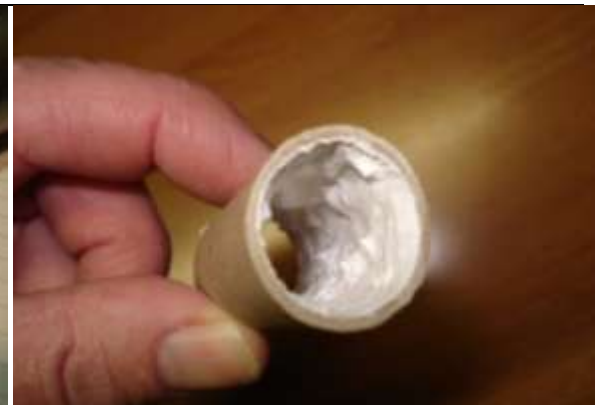
Figure B.2 Layer of gypsum paste

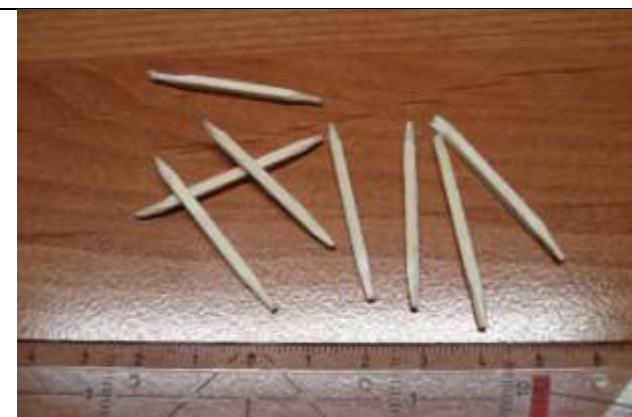
Figure B.3 Matches with sharpened ends

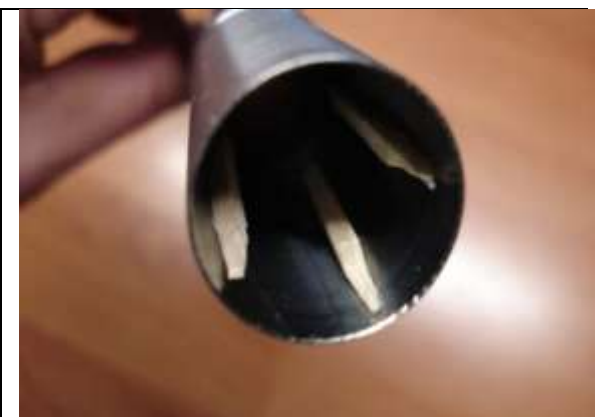
Figure B.4 Matches (3 pieces) glued in a tube

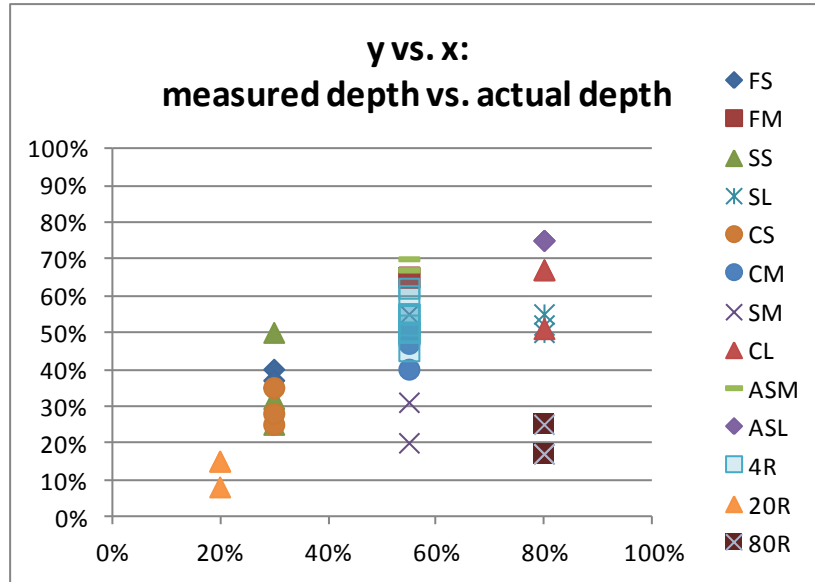
Figure C.1 Measured depth against actual depth of the wall reductions

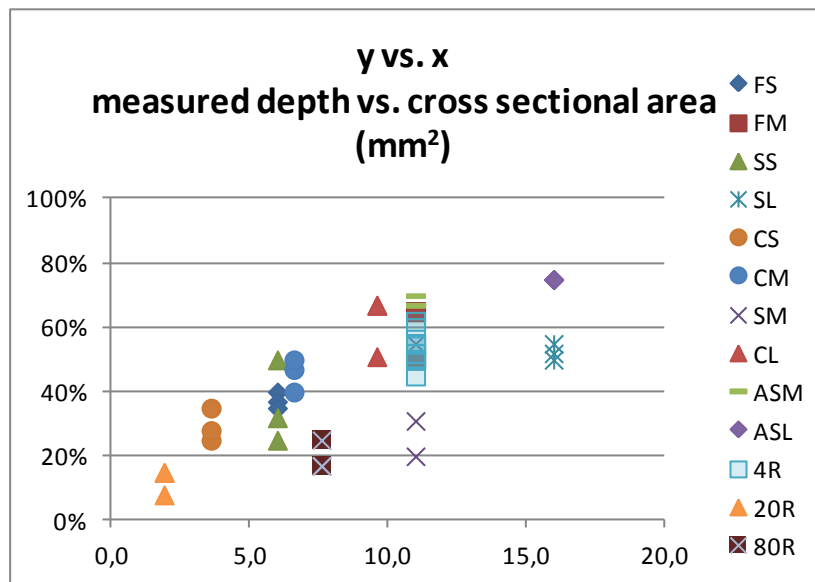
Another way of evaluating these results is to plot the measured depth against the cross sectional area of the wall reduction in order to remove the effect of the axial dimension of the defect and to account for the shape of the defect. This plot is presented in Figure C.2.

Figure C.2 Measured depth against the cross sectional area of the wall reductions

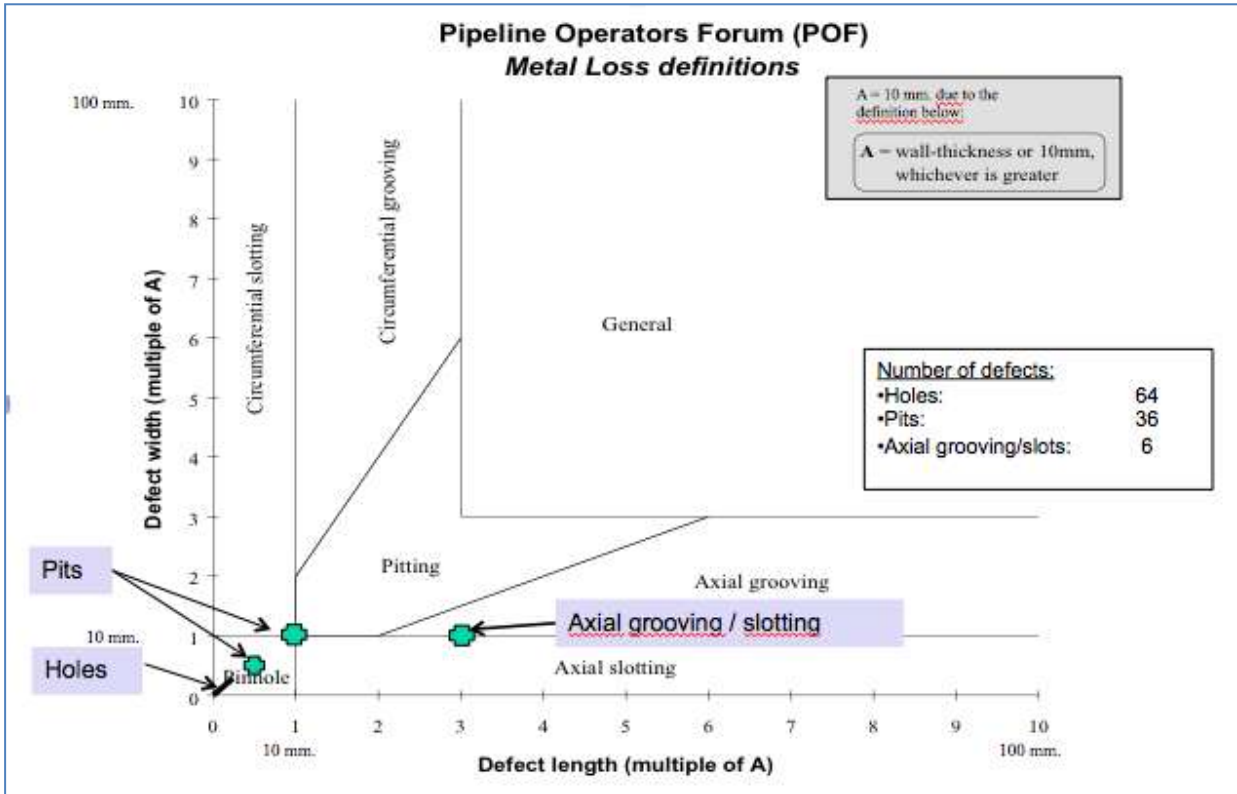
Figure D.1 Graphical presentation of metal loss anomalies from POF-guideline [7] including the position of the artificial defects from this validation program (see green coloured crosses).

In the application field of pipeline operators, the so-called POF-guideline (Pipeline Operators Forum) [7] is commonly used to describe the approach for the evaluation of pig inspection techniques. In this guideline a scheme is included for the definition of defects (named 'metal loss anomalies'). In above figure, the graphical presentation from this guideline is given. The sizes of the various artificial defects from this validation program have been plotted in this graph in order to clarify which types of defects were used according to the definition of the POF-guideline.
